**S-30 Beall 1961 Assembly Building -
Fire Records of the Oregon State Fire
Marshal and Fire Insurance Rating
Bureau**

LOSS REPORT

F. R. No. 5045

Date: September 28, 1961

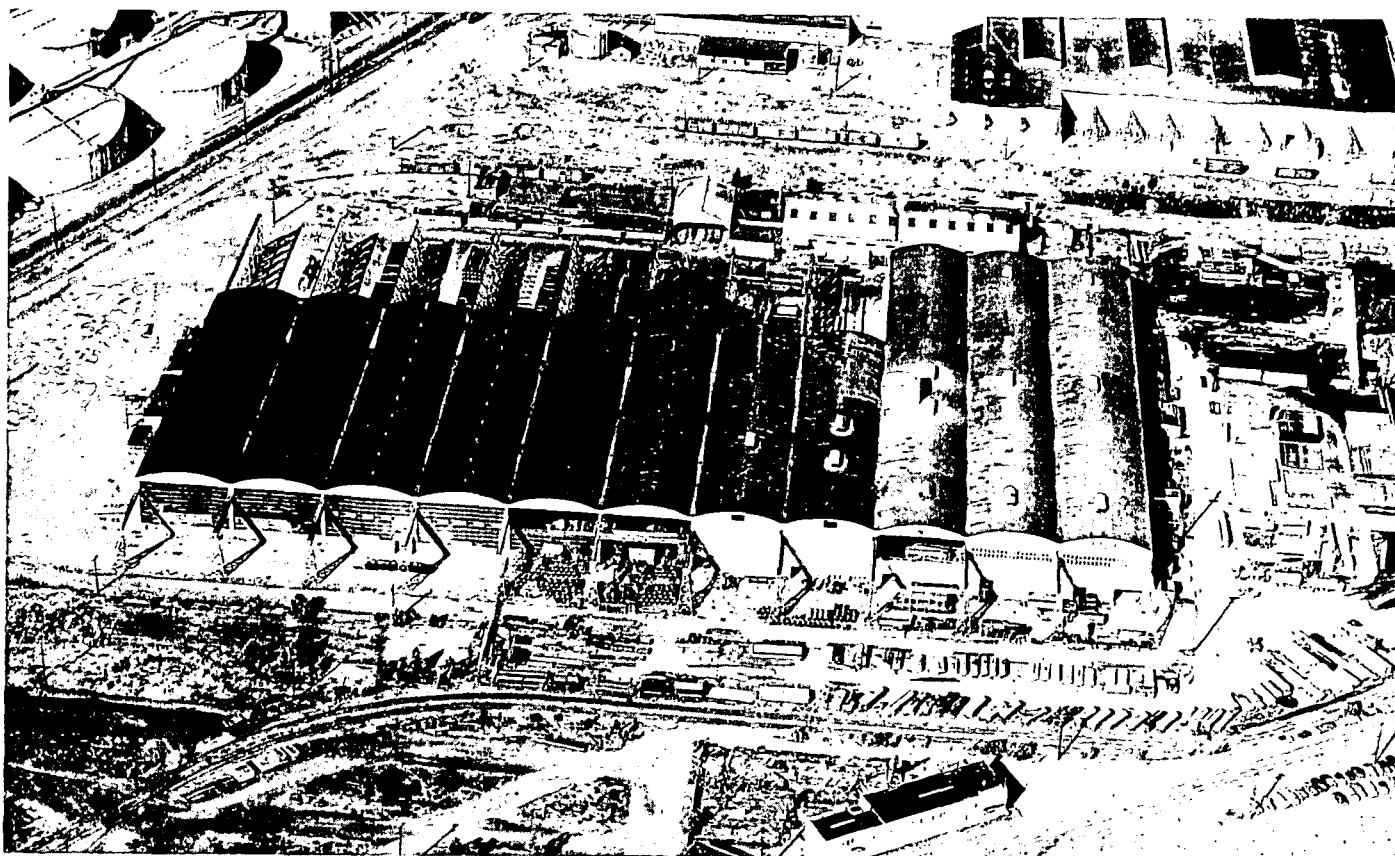
General view of the building before the fire looking Northwest. Note the small frame attachments at both ends of the building. Fire presumably started in the receiving-warehouse shed attached to middle of the outside end wall on the right.

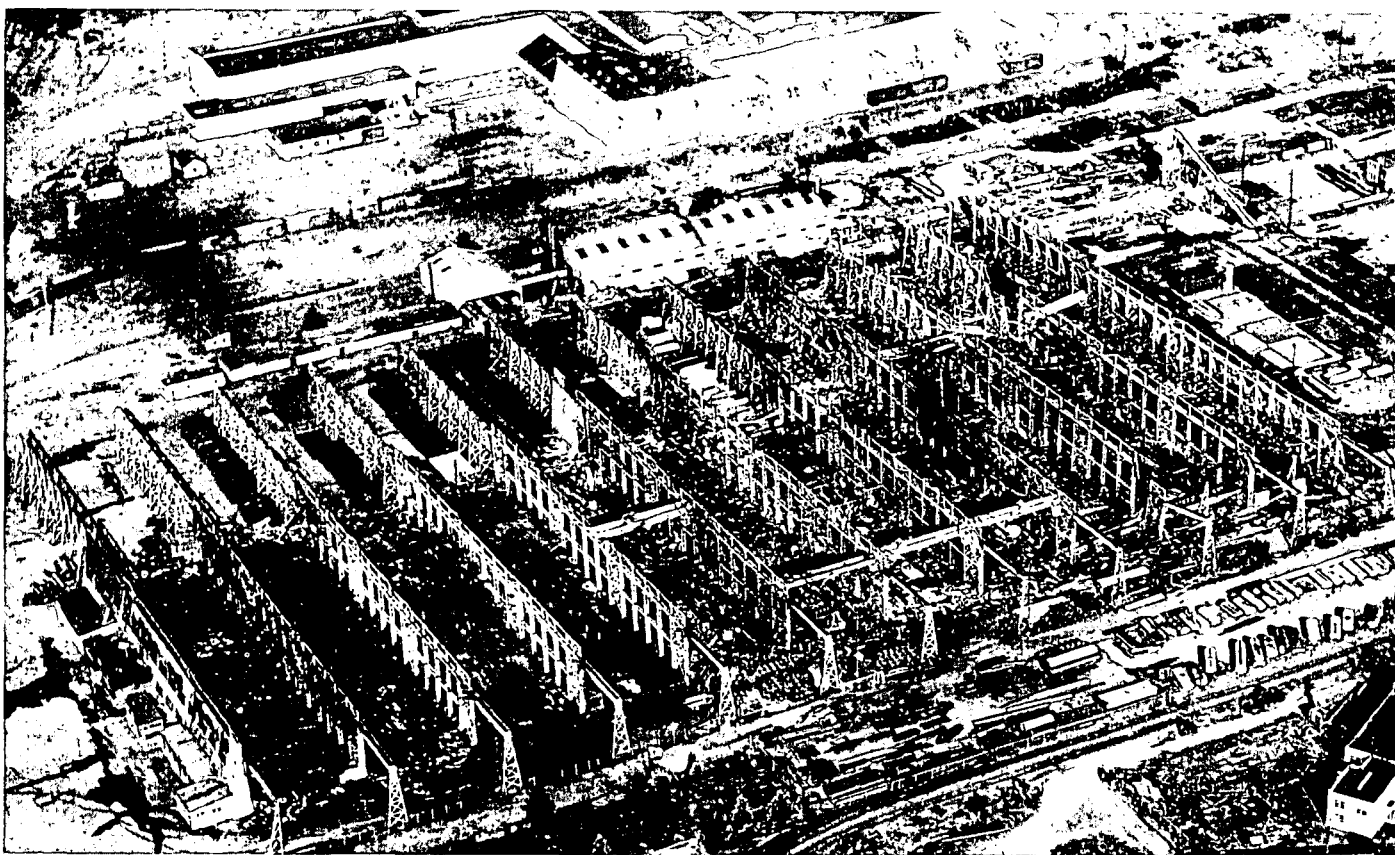
General view of the building after the fire. Note warping of structural steel framework. All combustible portions destroyed except small frame office and tool rooms attached to outside end wall on the left.

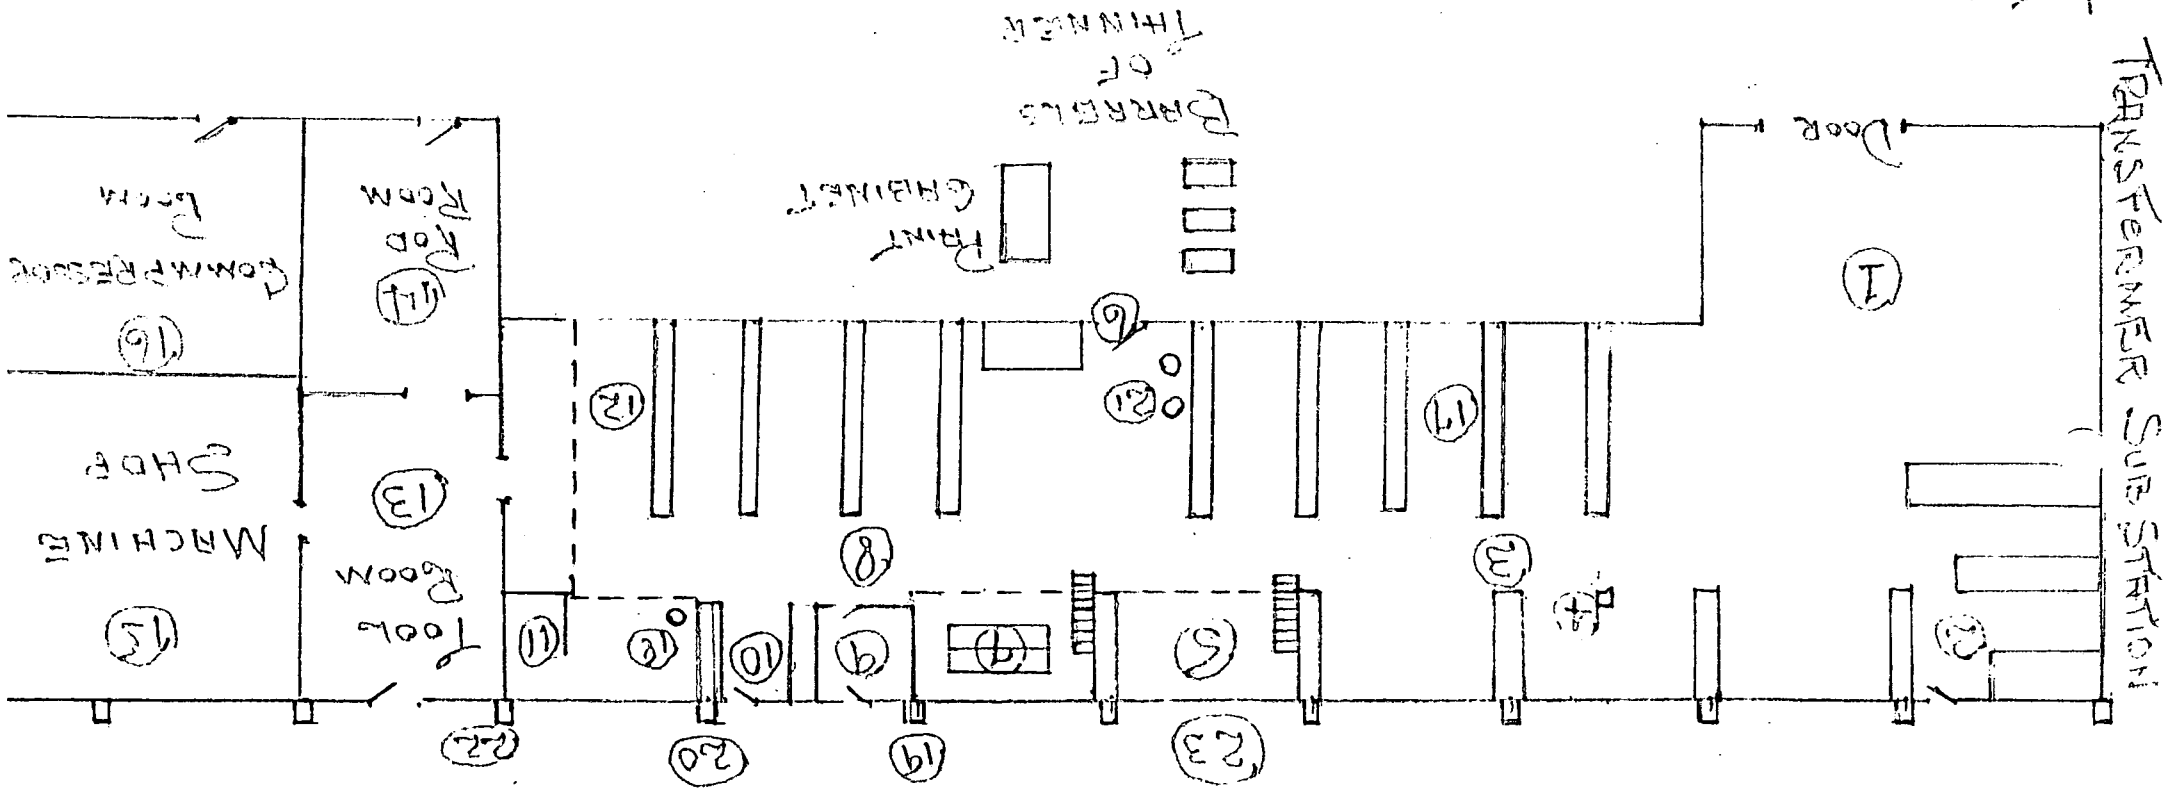
PLAN OF STORE RECEIVING SECTIONS #1 AND 2 BAY 11

Based on the statements of the 4 employees and the plant guard who were in the area when the fire was discovered who state that the first visible smoke and flame was in the one-story lean-to Store Receiving Section #2 and was starting to break through the frame partition dividing the storage area from Bay #11, we are of the opinion that the fire originated in this area. The actual cause remains undetermined. Attempts to pin point the source of ignition and the exact point of origin would be mere conjecture. From their statements it would appear that once ignited the flames spread rapidly in the combustible and flammable contents of the storage area sweeping through the frame partition into the Bay where it involved additional combustible storage on balconies arranged along the north wall of the Bay. A 440 volt aerial service line suspended from the steel columns and girders approximately 18-feet from the floor along the north wall of Bay #11 revealed evidence of having been subjected to heavy arcing. This service which extended the entire length of the wall was in our opinion a factor in the rapid spread in Bay #11. A second 3-wire 440 volt line utilized as a trolley wire for the overhead crane was attached to the heavy steel girder which served as a crane track. This line extending the full length of the north wall also revealed evidence of arcing and was probably a factor in aiding the spread of the flames into the roof section. The accumulation of dust and residues from the numerous fabrication and manufacturing processes carried on in the structure was another possible factor in the rapid spread. Grain dust in the middle and southern Bays was also a probable factor.
